THE HOUSE AT GLENMONT

HOME OF THOMAS EDISON

Historic Structure Report

THE HOUSE AT GLENMONT
HISTORIC STRUCTURE REPORT

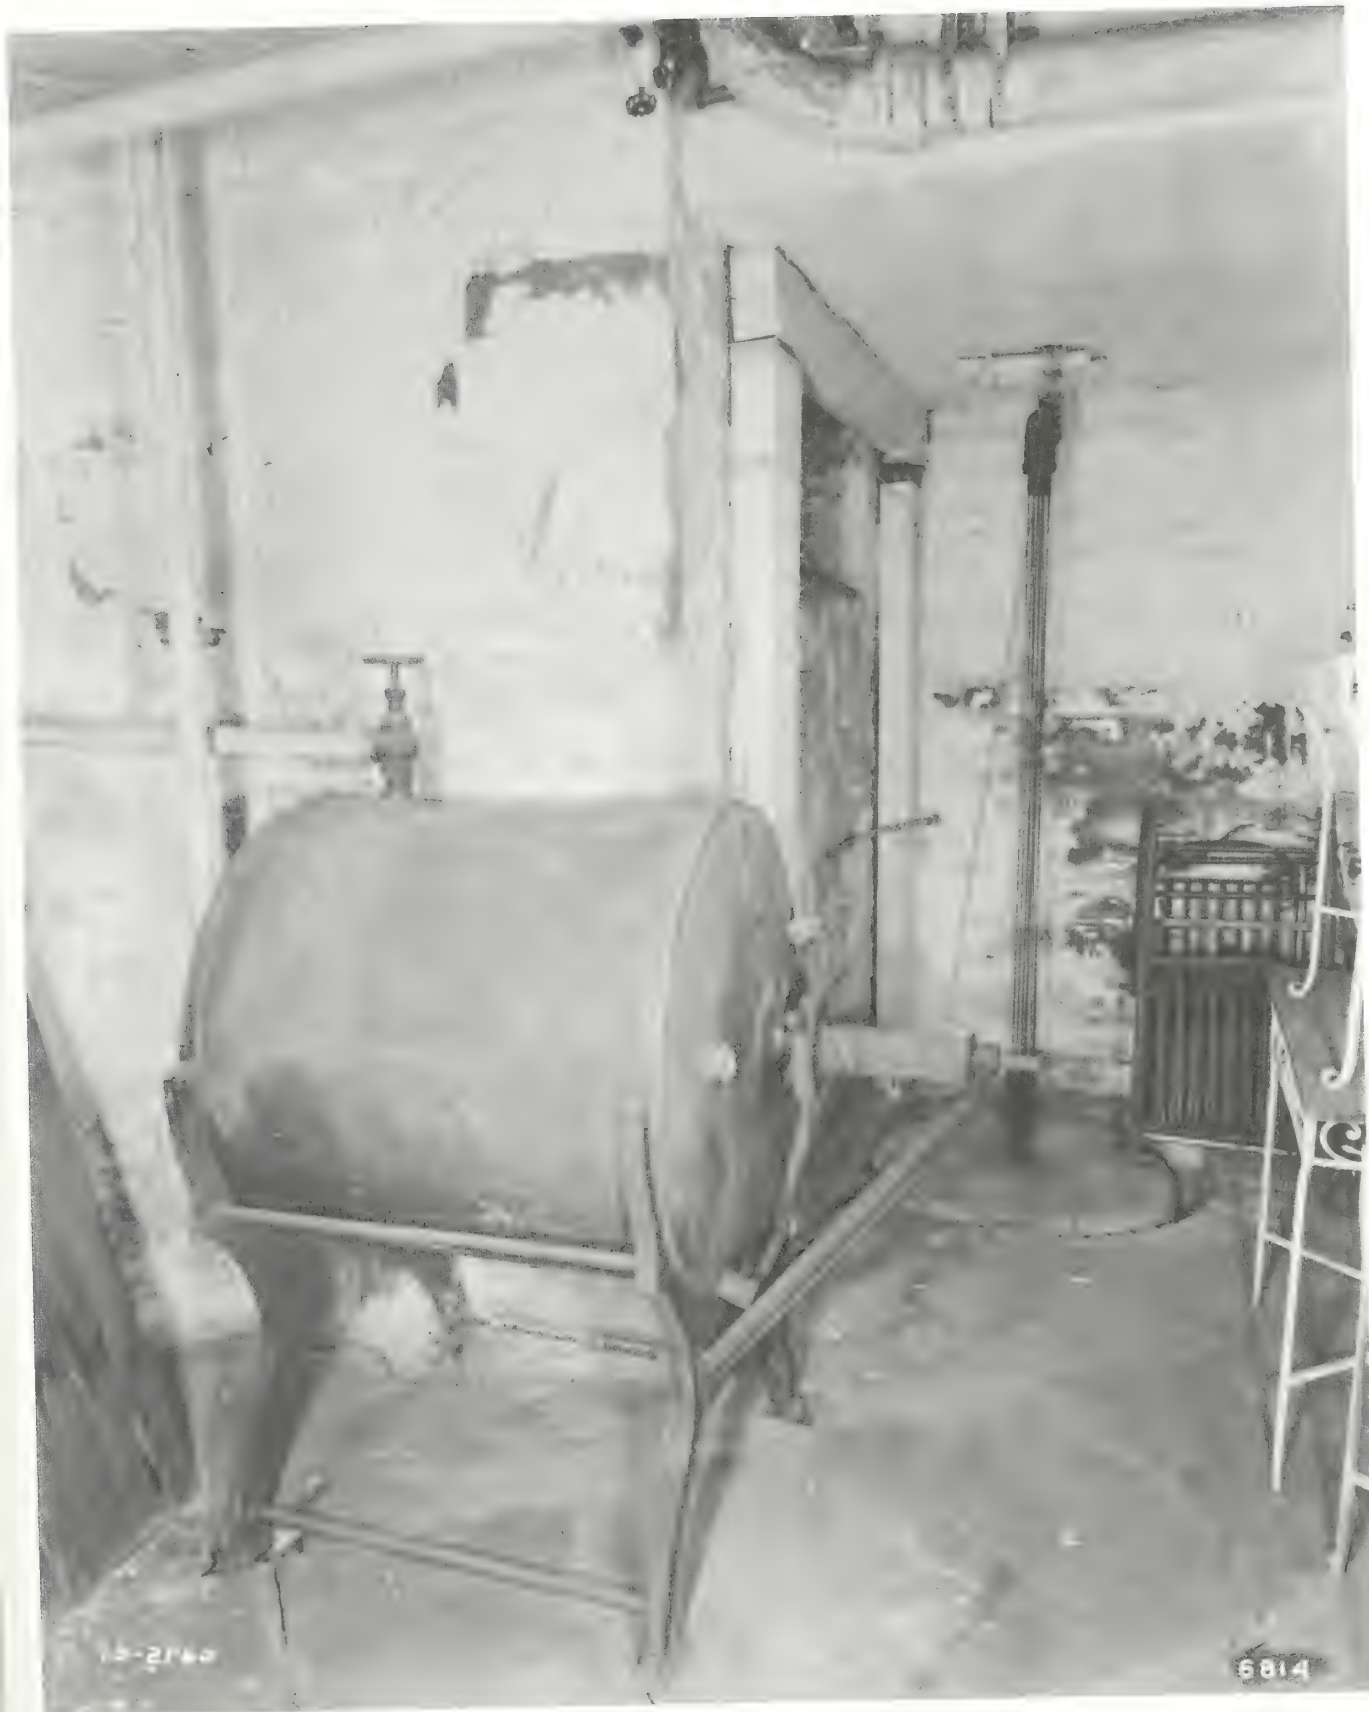
Figure 37. Room B9, northeast corner, showing the obsolete Springfield Gas Machine, 1960.

The Edison family used the gas-making equipment, including the "gas machine," until sometime before 1921. It was noted as being "obsolete" by the time of the residence appraisals of 1921, 1924, and 1931. The 1931 appraisal described the equipment in the cellar as follows:

1 Springfield gas machine, #1822, receiver 32" x 32" diameter, Gilbert and
Barker Mfg. Co. (obsolete).

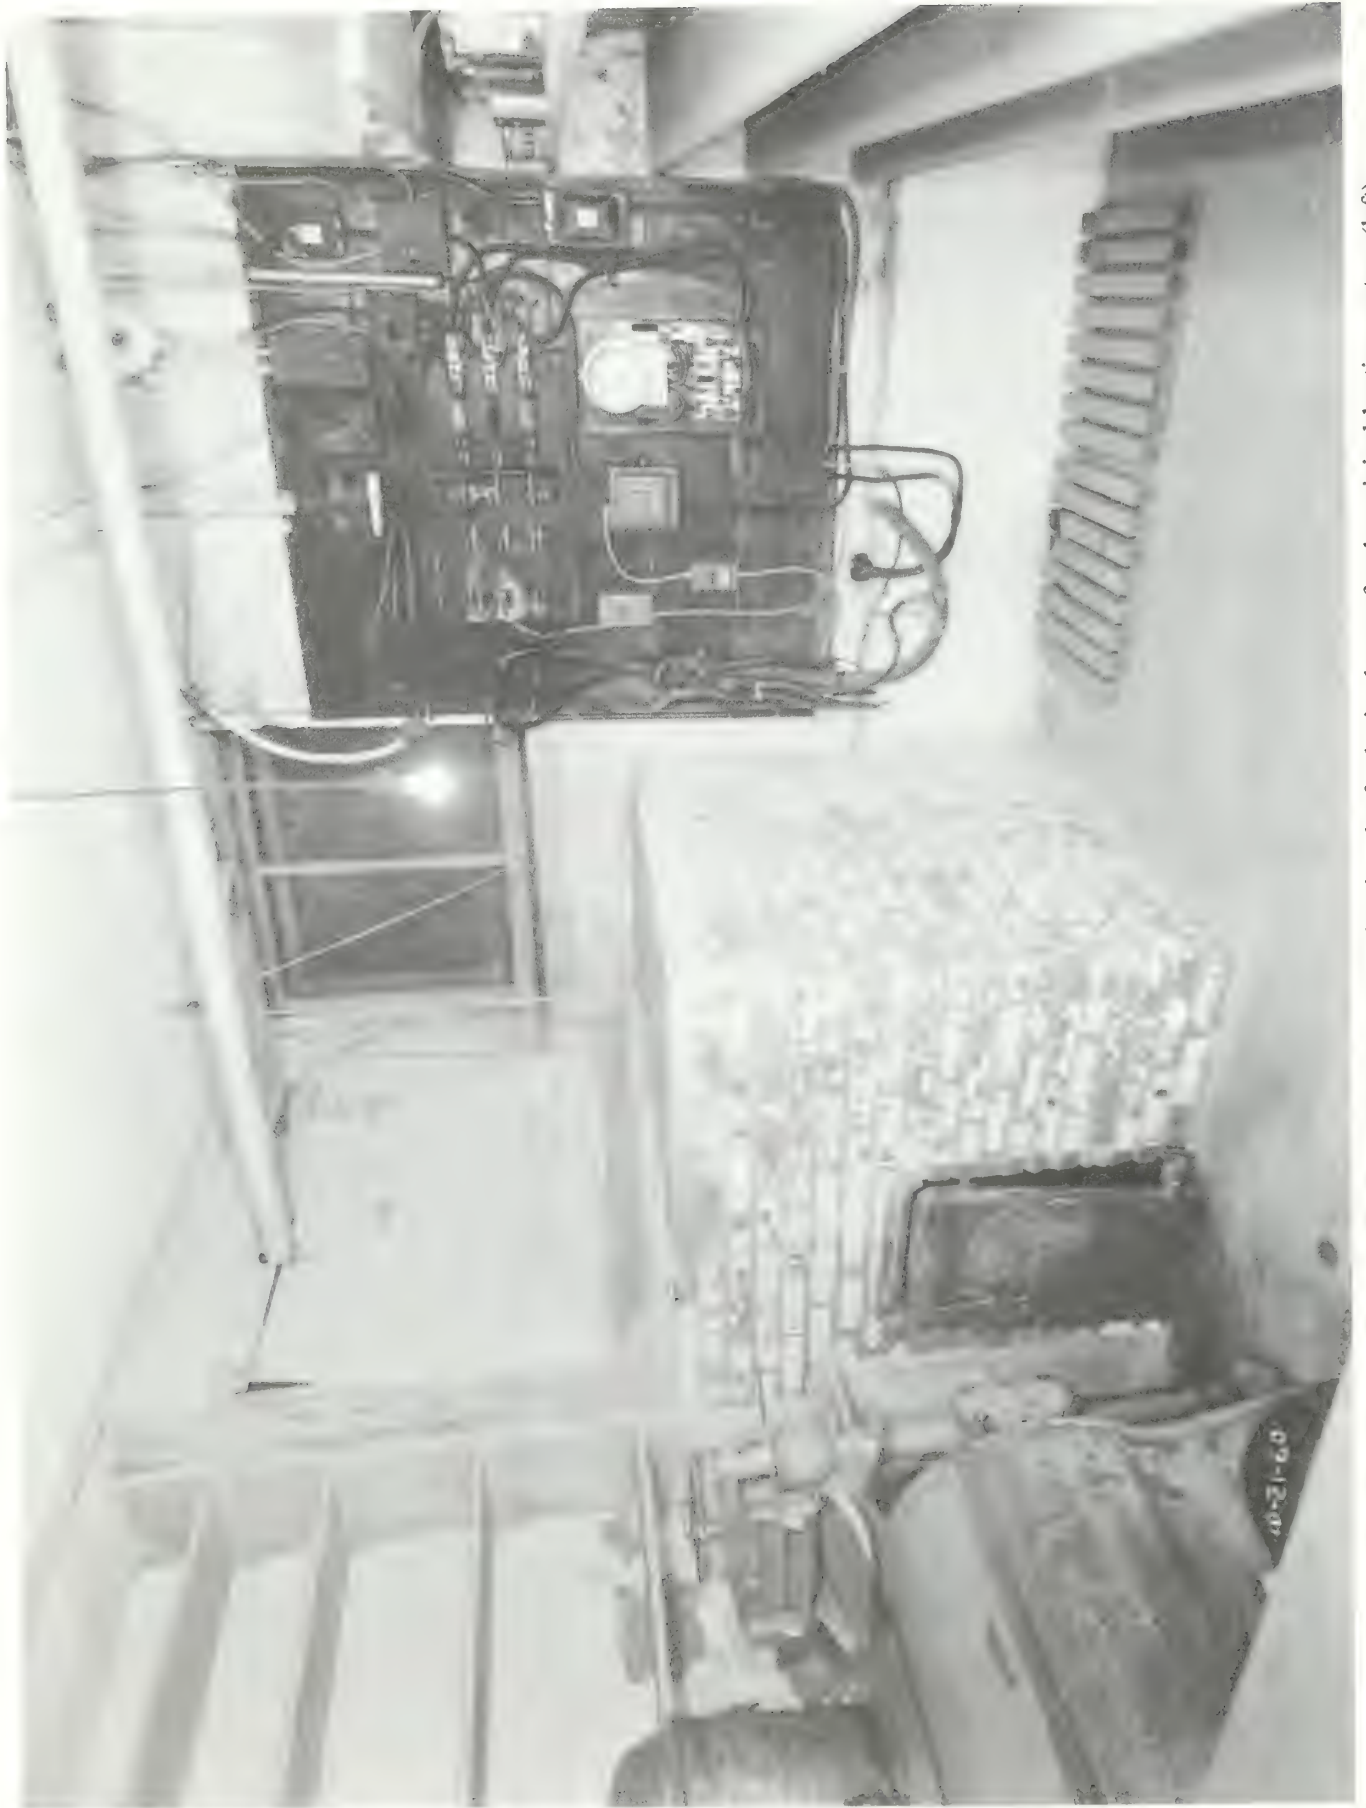
Figure 38. Store Room #2 (Room B11), northeast corner, showing the fresh-air plenum for the original heating system (left), and the electrical panel for incoming service (right), 1960.

Two new electrical distribution panels replaced the old entrance panel in 1968. The two new panels are mounted to the south wall. Both are housed in metal boxes. One of the boxes is labeled "Panelboard A." Circuit breakers within the box are identified as being for the lights, receptacles, and other electrical fixtures that are outside, in the cellar, and in the first story. The second electrical panel box is unlabeled.

The floor channel is missing today from Room B11, having been filled in and covered with concrete at an unknown date. This had occurred by October 1960, based on a photograph of the room that shows the floor as it appears today. The floor channel appears to have run in a north-south direction, from the brick plenum to the south interior wall. The place where the channel intersected the south wall can be determined from the locations of the surviving floor channels in adjacent Room B9, with which it connected.

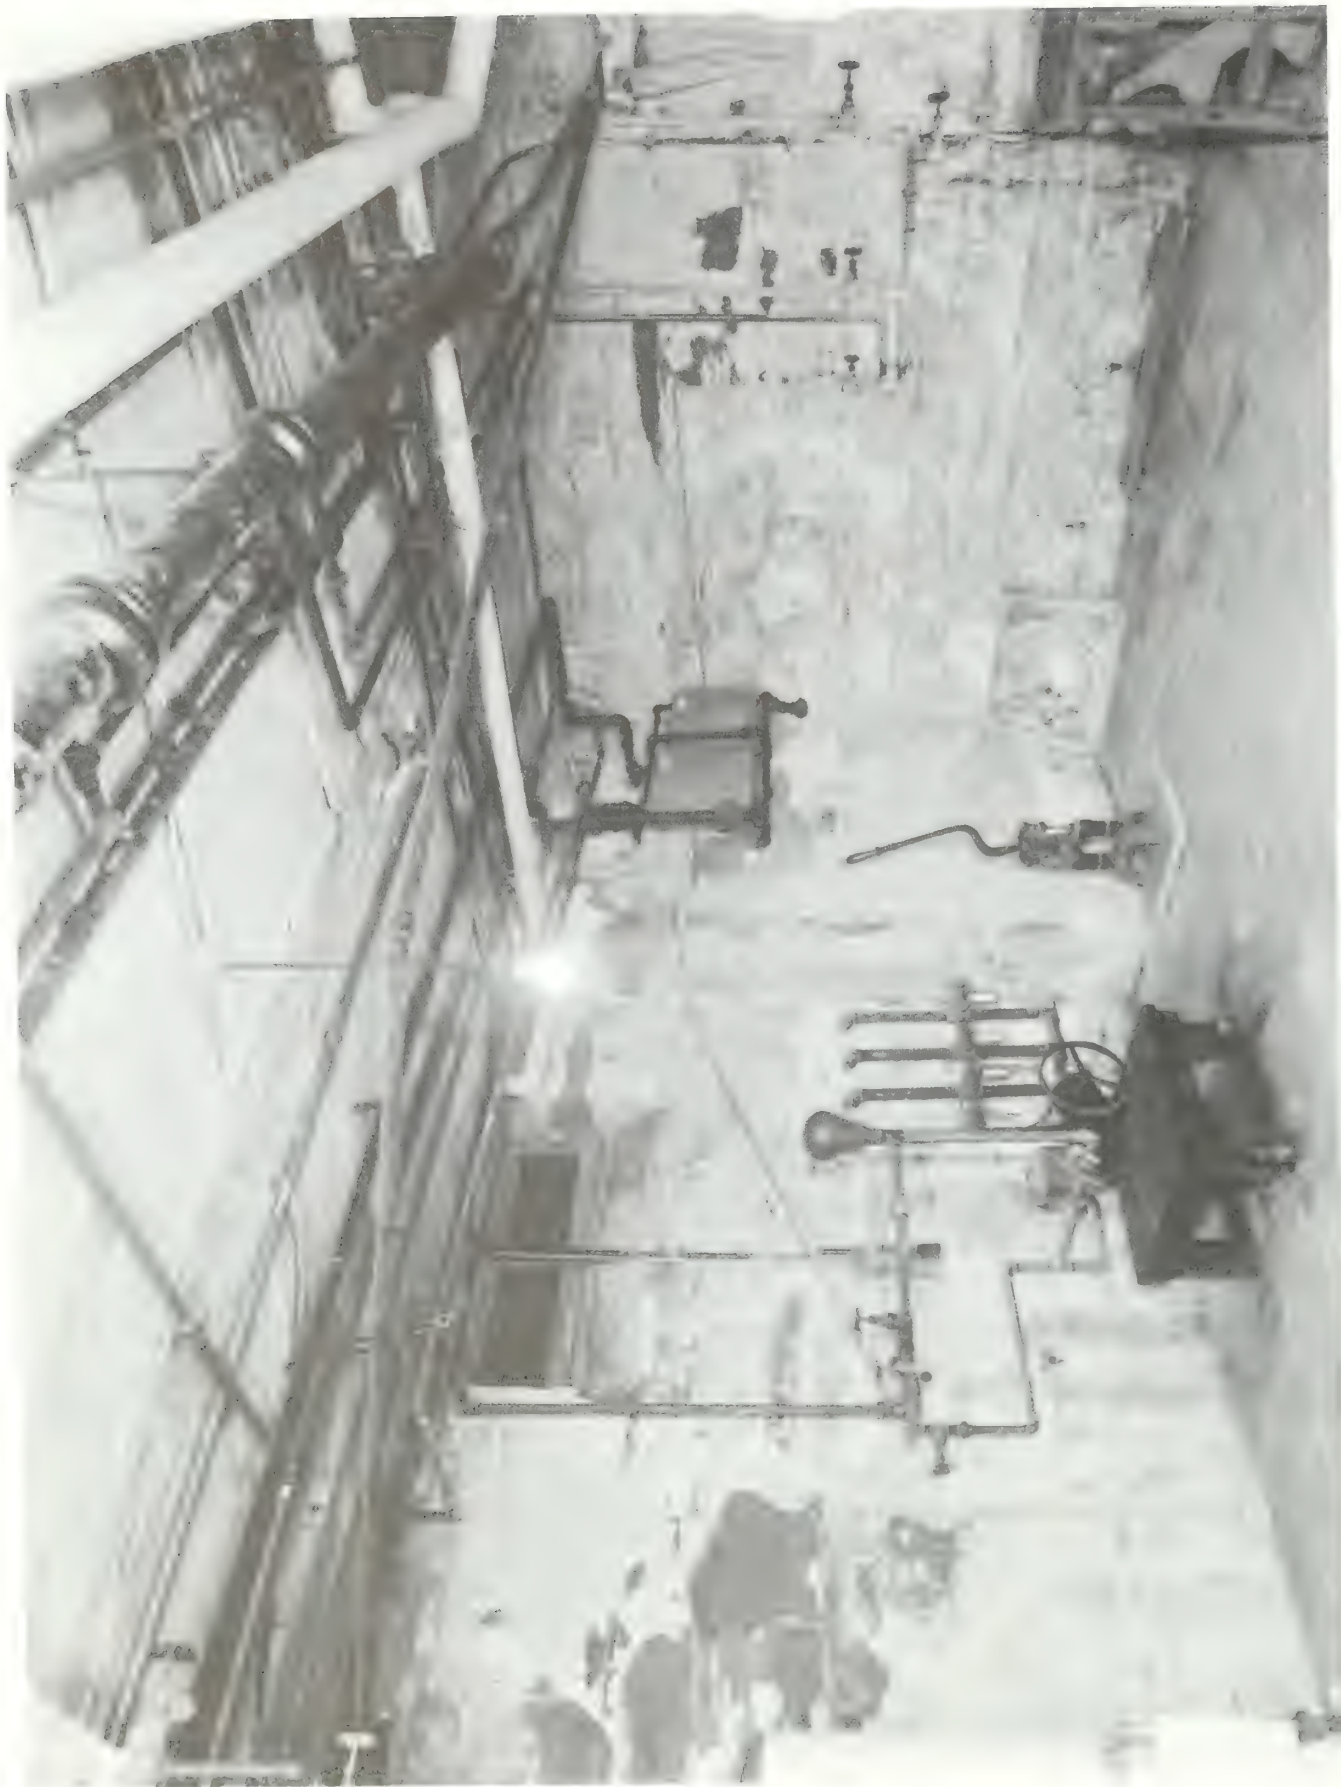
Figure 39. Pump Room (Room B14), northwest corner, showing the cistern valves and water pumps, 1960.

Plumbing fixtures include the entrance pipes from the rainwater cisterns, a pump, and various shut-off valves. Two hot-water heaters formerly in the room—one present in 1921, the other there in 1931—are missing today.

The pump in the room today has written on it "Seneca Falls, N.Y. 35-B-1." It is not known for certain if this is the same pump that was in the room during Thomas Edison's lifetime, or if it was installed at a later date. The motor that powered the pump is missing. It most likely became obsolete in 1950, when the electrical service in the house was changed from direct current to alternating current. Public water was probably used exclusively after 1950.

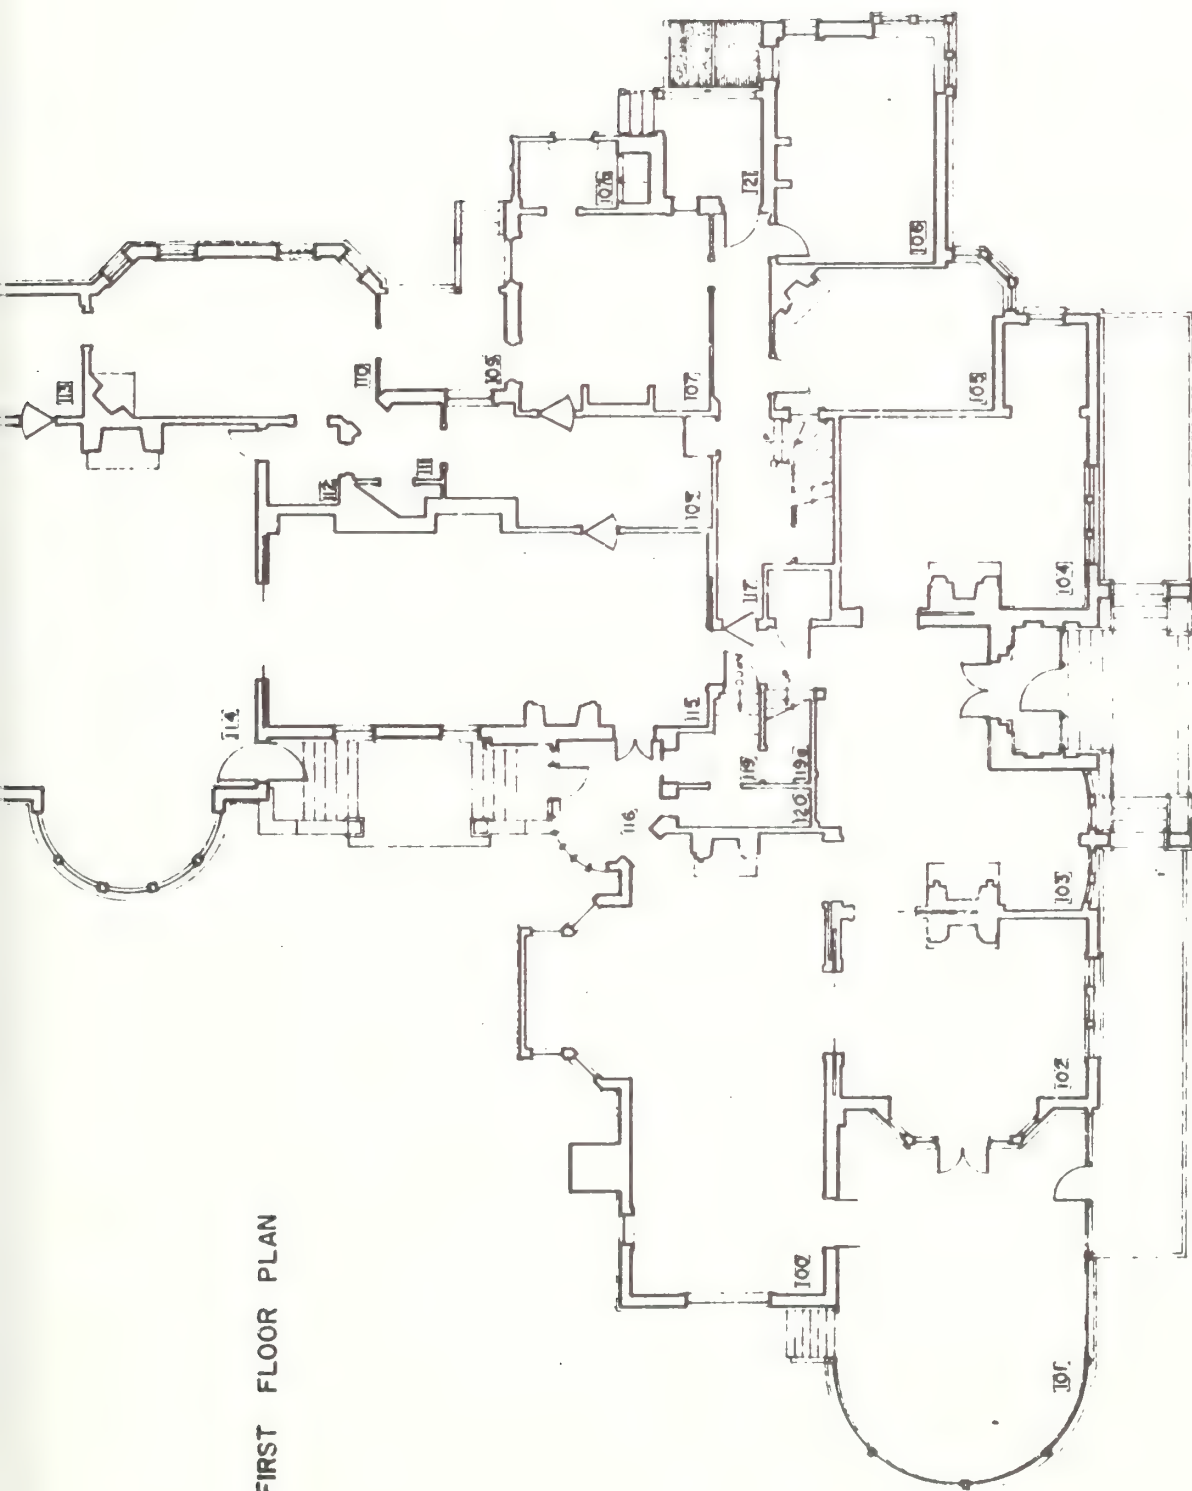
FIRST FLOOR PLAN

Figure 40. First-floor plan, 1963.

REDRAWN FROM NPS DRAWING-NAS ED. 3011 SHEET 3
DRAWN BY JOHN G. WHITE, 1963

The Telephone Room is tucked beneath the Main Stairway to the second story. It occupies an interim story between the first and cellar stories, and is reached from the first story by descending a flight of five steps. The dimensions of the “Phone Room” were recorded by the residence appraisal of 1931 as being roughly 7 feet square. This does not seem to take into account an ell off the southwest corner of the room (see figure 40).

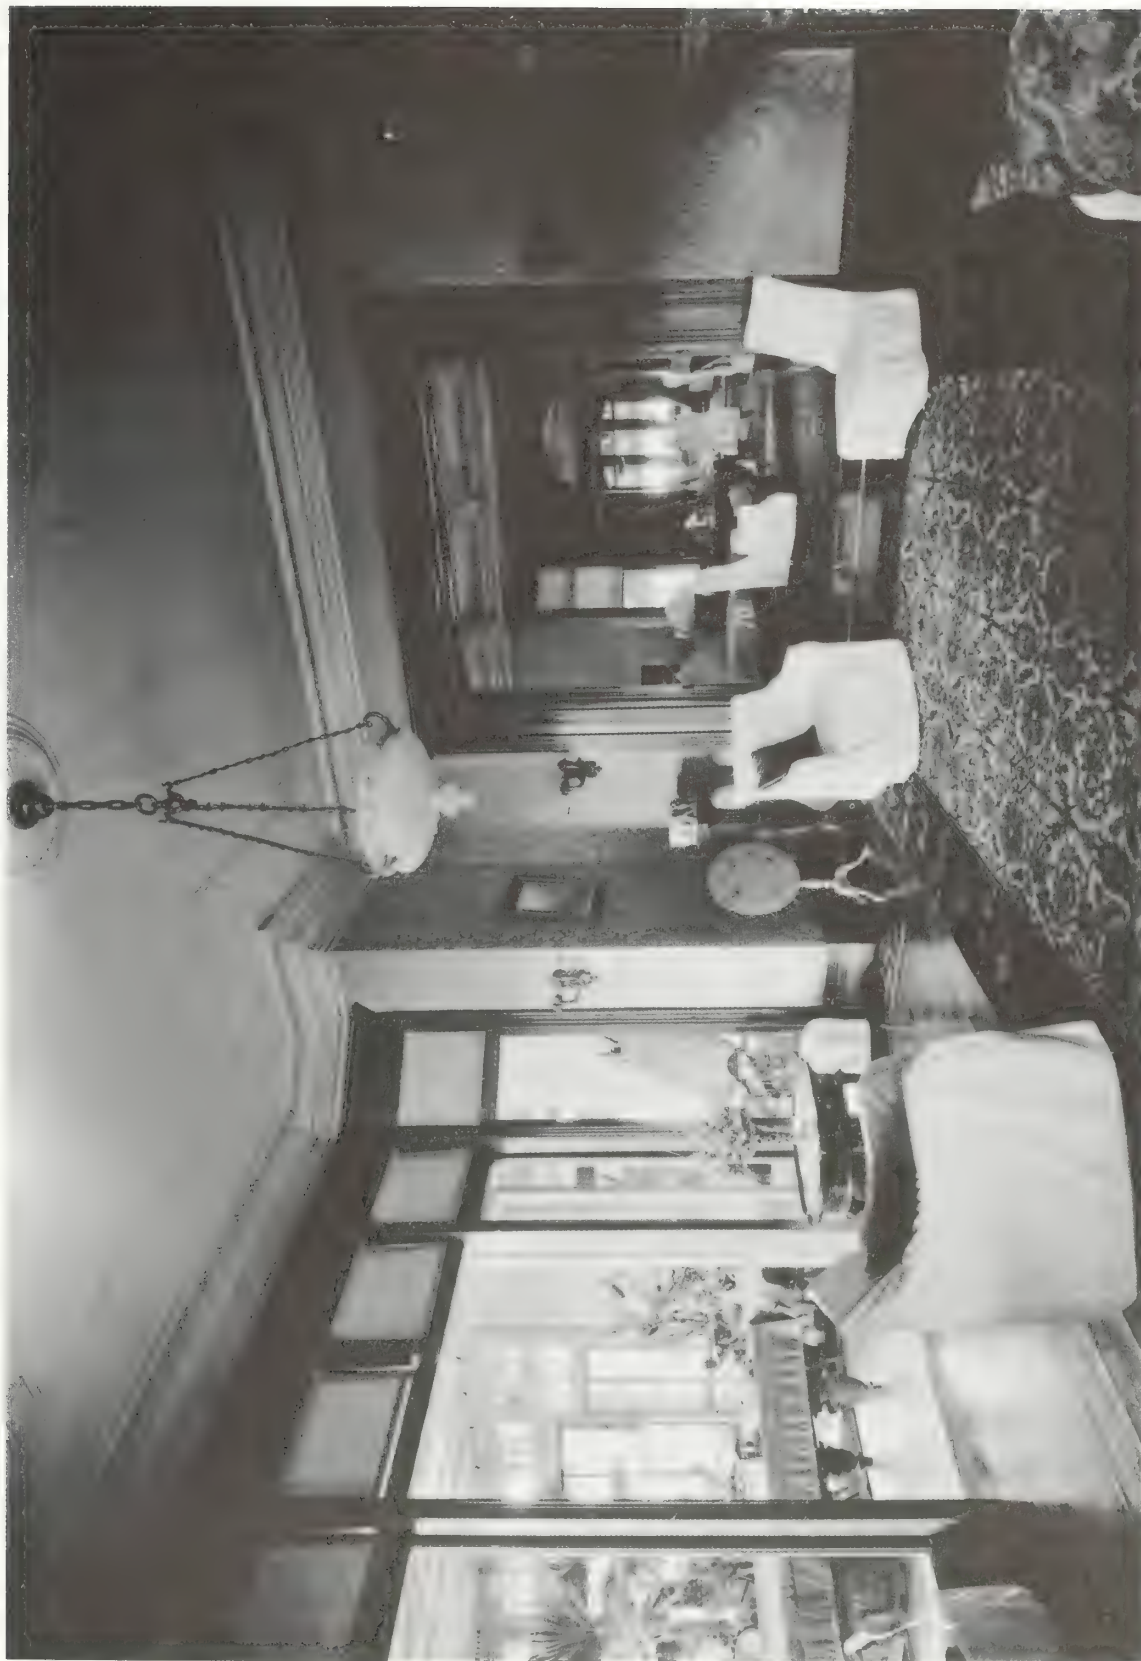
Figure 57. Reception Room (Room 102), looking southwest, 1918.

The new south doorway is first seen in a photograph of the room dated 1918 (fig. 57). Its doors appear to be the same as those that exist today. The doorway was also described in the residence appraisals of 1921, 1924, and 1931. Of these, the most detailed is the 1931 appraisal that listed "1 Pair doors, 4'2" x 7'10" x 2'0", 2 lights, full brass bolt and 4 side lights, 2'0" x 7'10", 1 light and 22" transom."

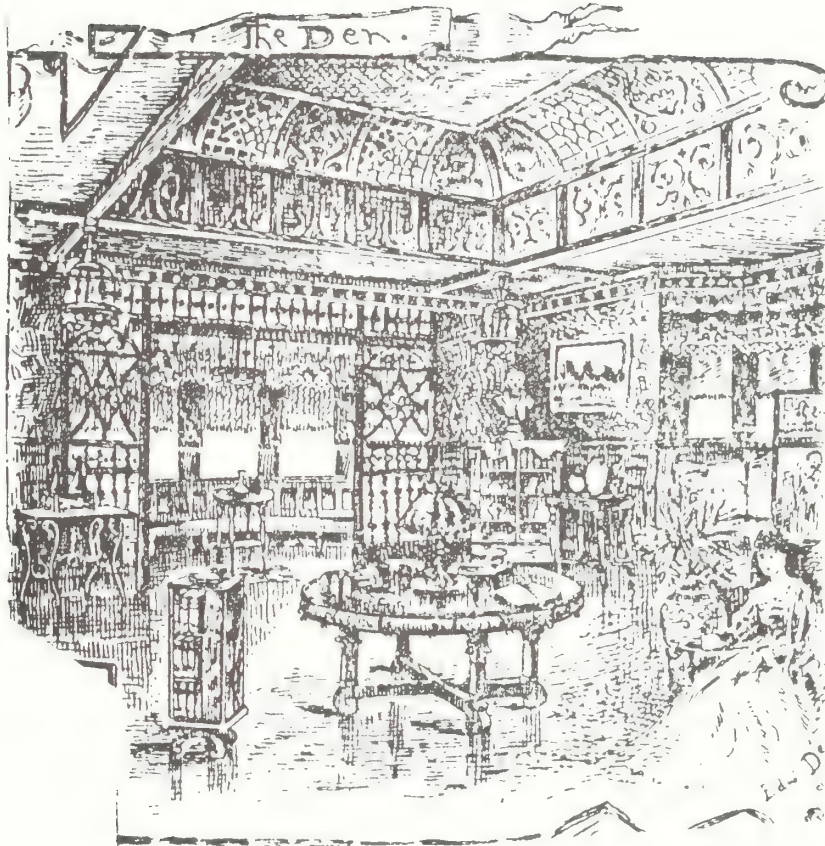
Figure 89. Sketch of the Den (Room 114), looking southwest, 1891.

Alterations were made to the woodwork when the room was remodeled in 1935. The most significant change was the removal of the original wood screen from the south-wall bay. The estimate for the work by Mrs. Renner dated July 1, 1935, described "removing existing grill partition and patching." The appearance of this screen is well-documented by several early views of the room (figs. 89 and 91-92).

The earliest visual documentation of the light fixtures is a sketch of the Den that accompanied the 1891 article (fig. 89). The earliest photograph, published in 1892, shows the two light fixtures at the north end of the room (fig. 90).²⁰⁹

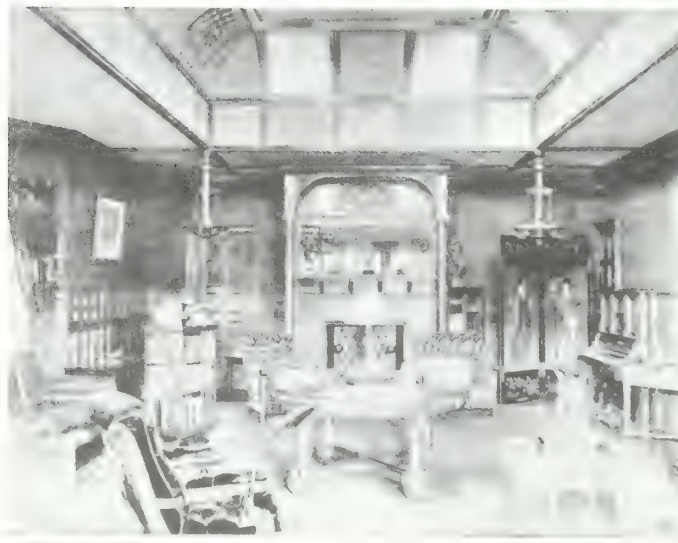
EDISON'S DEN.

Figure 90. Den (Room 114), looking north, circa 1890.

Also altered in 1935 was the wood fireplace mantel at the north end of the room. The original appearance of the mantel is seen in a photograph published in 1892 (fig. 90). The estimate of July 1, 1935, described "removing present over-mantel and pilasters [sic: columns], re-setting pilasters [sic] under present mantel shelf."

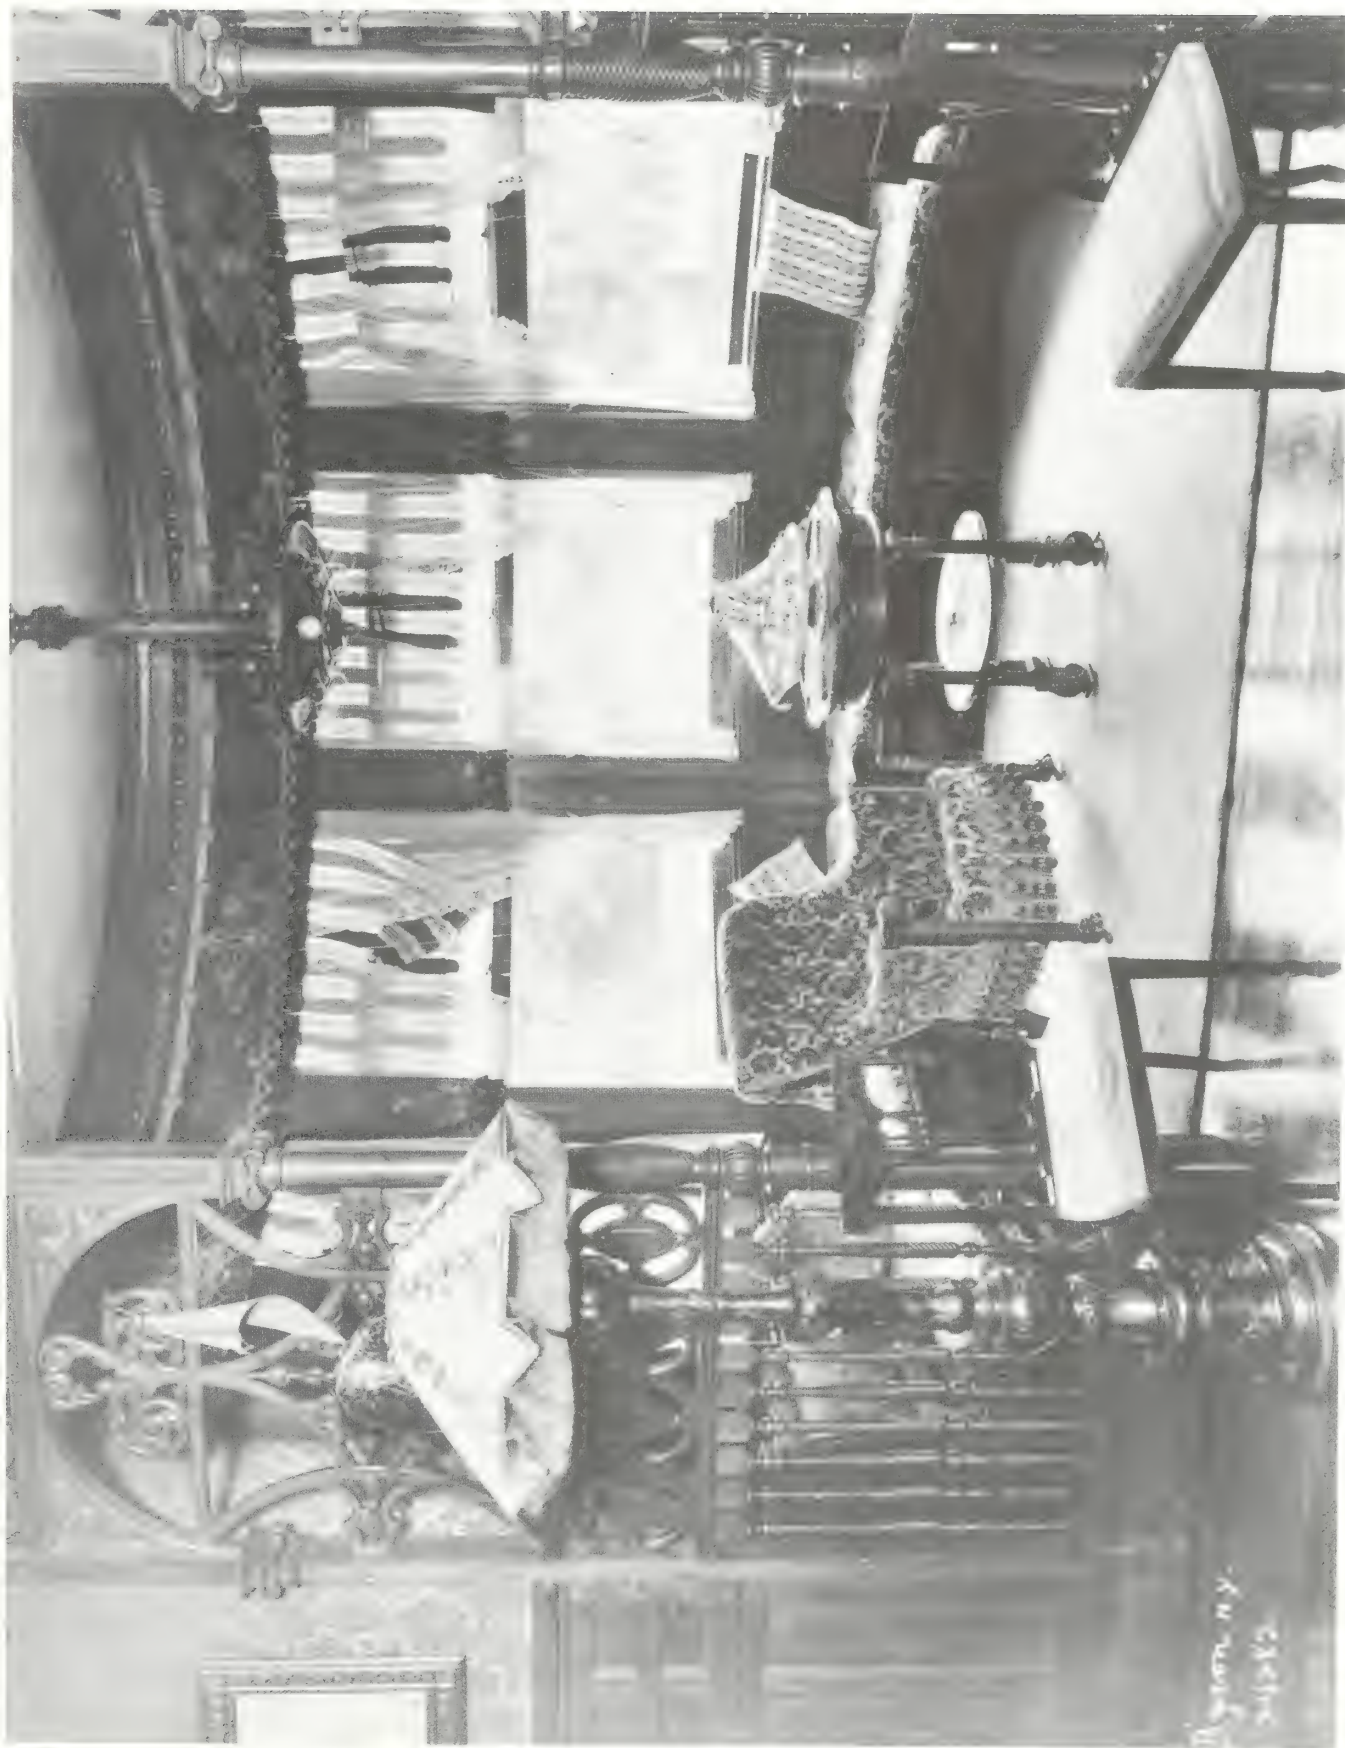
Figure 91. Den (Room 114), south bay window, 1907.

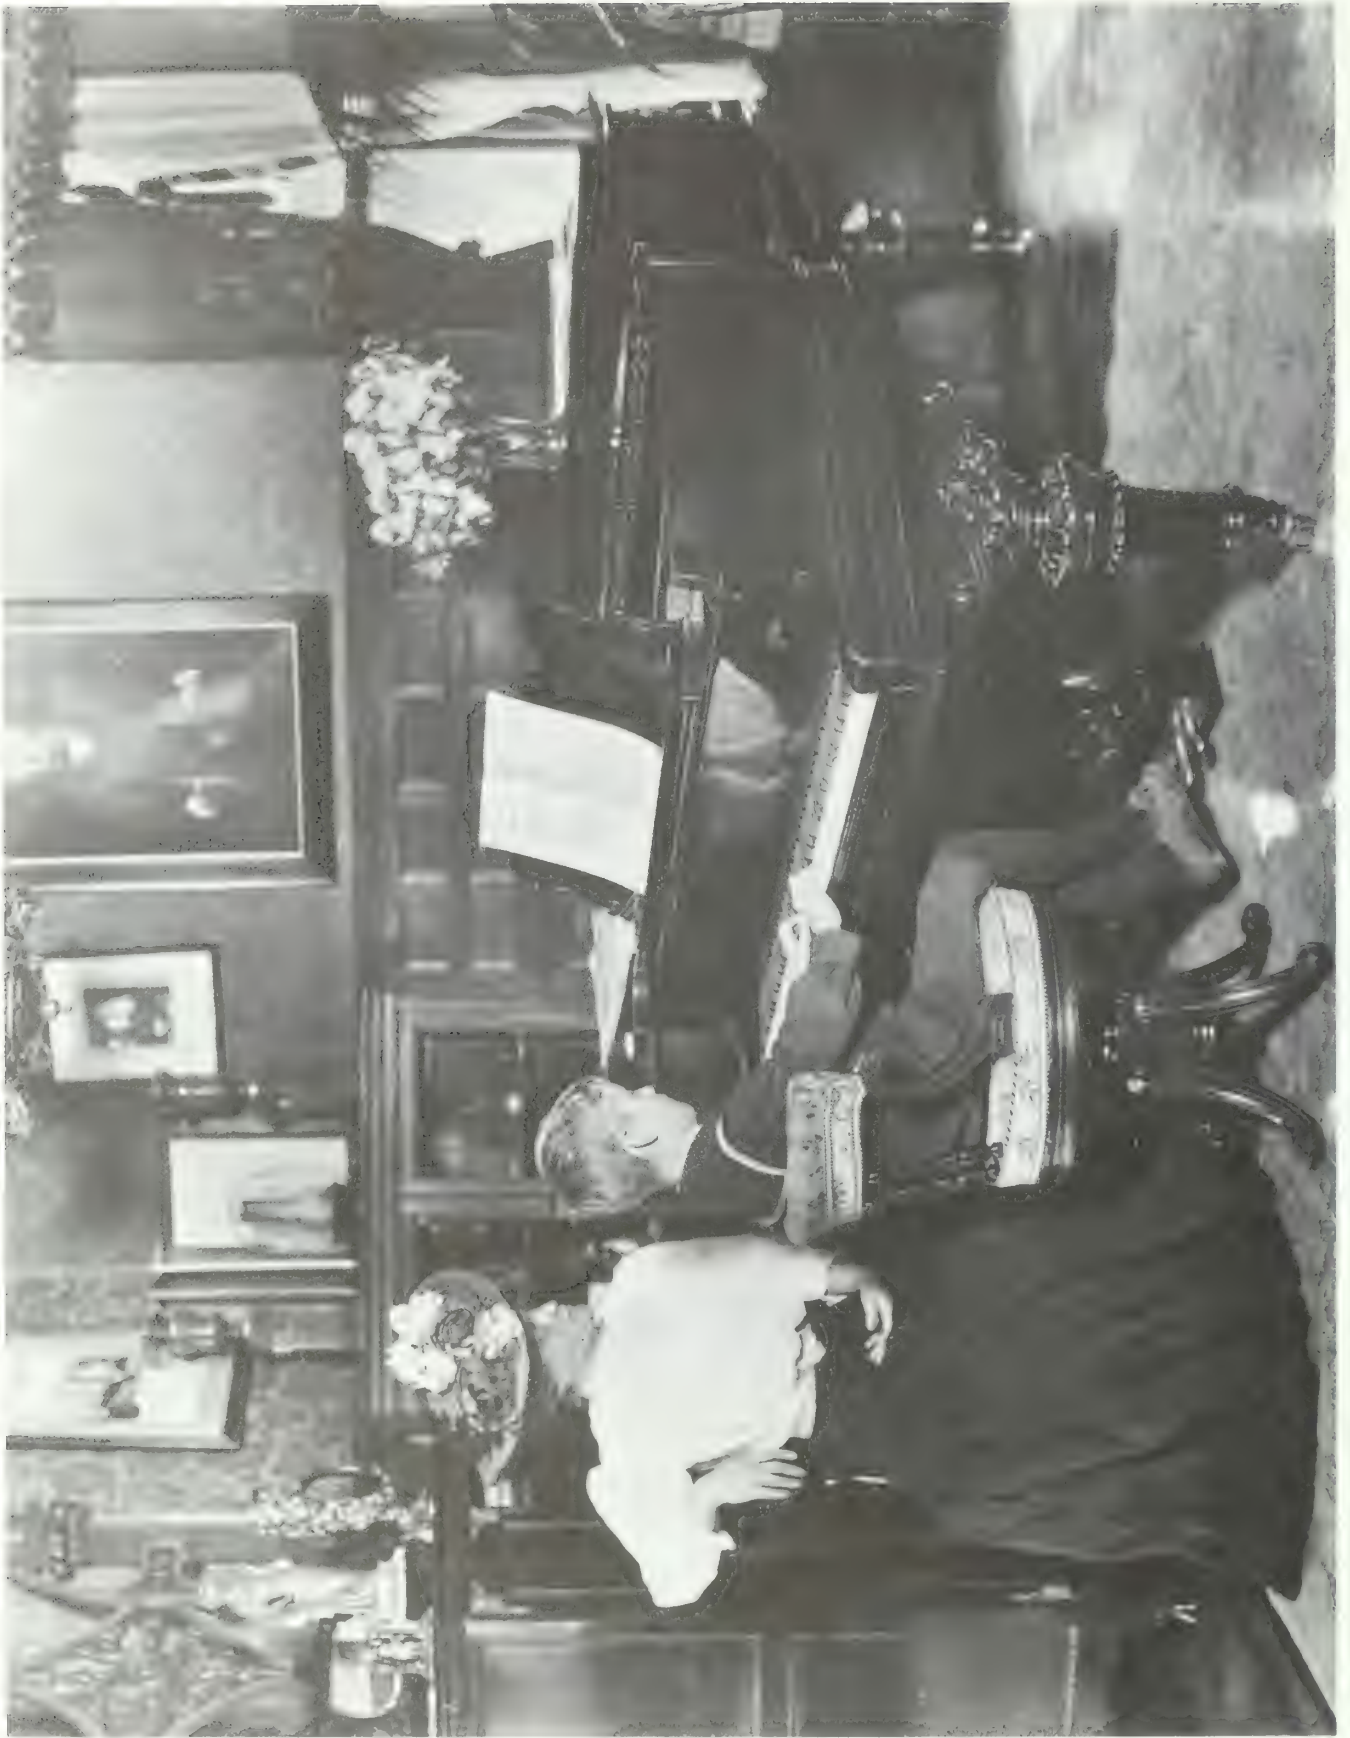
Figure 92. Den (Room 114), southwest corner, 1907.

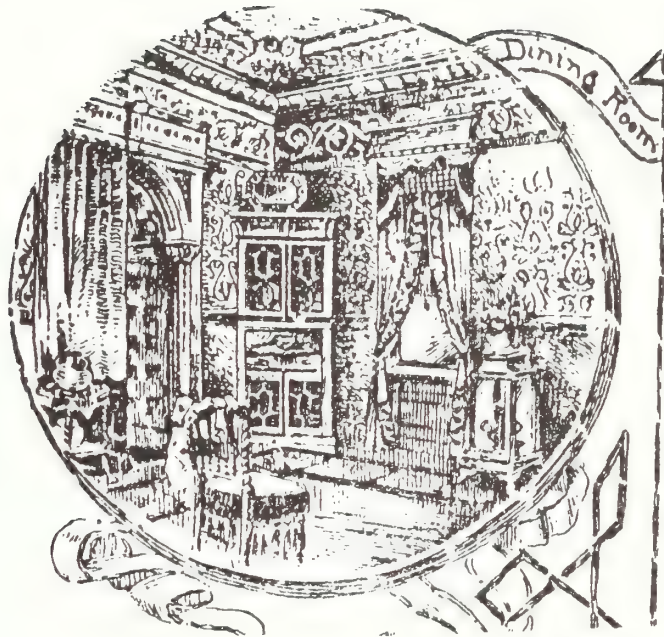
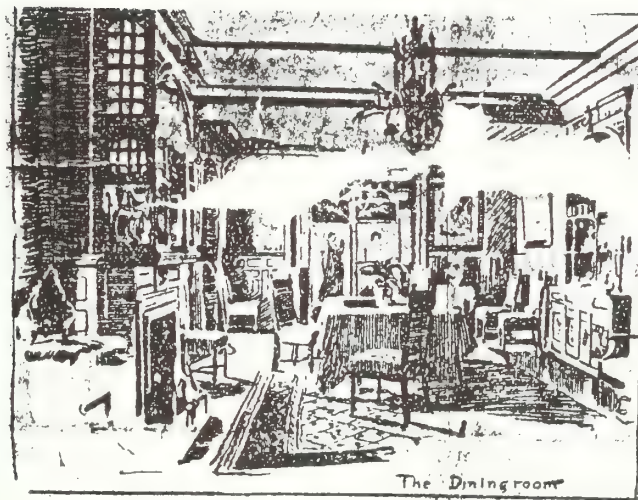
Figure 102. Two early sketches of the Dining Room: one showing the southeast corner (top, 1891); the other being a view looking west (bottom, 1894).

The article was accompanied by the earliest-known view of the room—a sketch showing the southeast corner (fig. 102).

This article was illustrated with a sketch, which was a view looking toward the west (fig. 102).

figuring.”²³³ An accompanying sketch shows the walls as having a curvilinear design, with a wide patterned border near the ceiling. The ceiling itself also appears to have had a decorative treatment (fig. 102). No samples of the wallpaper are known to survive. Remnants of the ceiling decoration, on the other hand, may exist behind the later canvas finish.

The original chandelier is believed to have been replaced by two new chandeliers when the house was electrified in 1887. These were described by the inventory of 1891 as “2 electroliers.” More detailed was an article published in 1894 that said, “There are two superb chandeliers, fitted like the others through the house with electricity.” A sketch illustrating the article shows one of the two fixtures as being large and elaborate, featuring a wide spray of arms (fig. 102). No photographs of the electroliers are known.

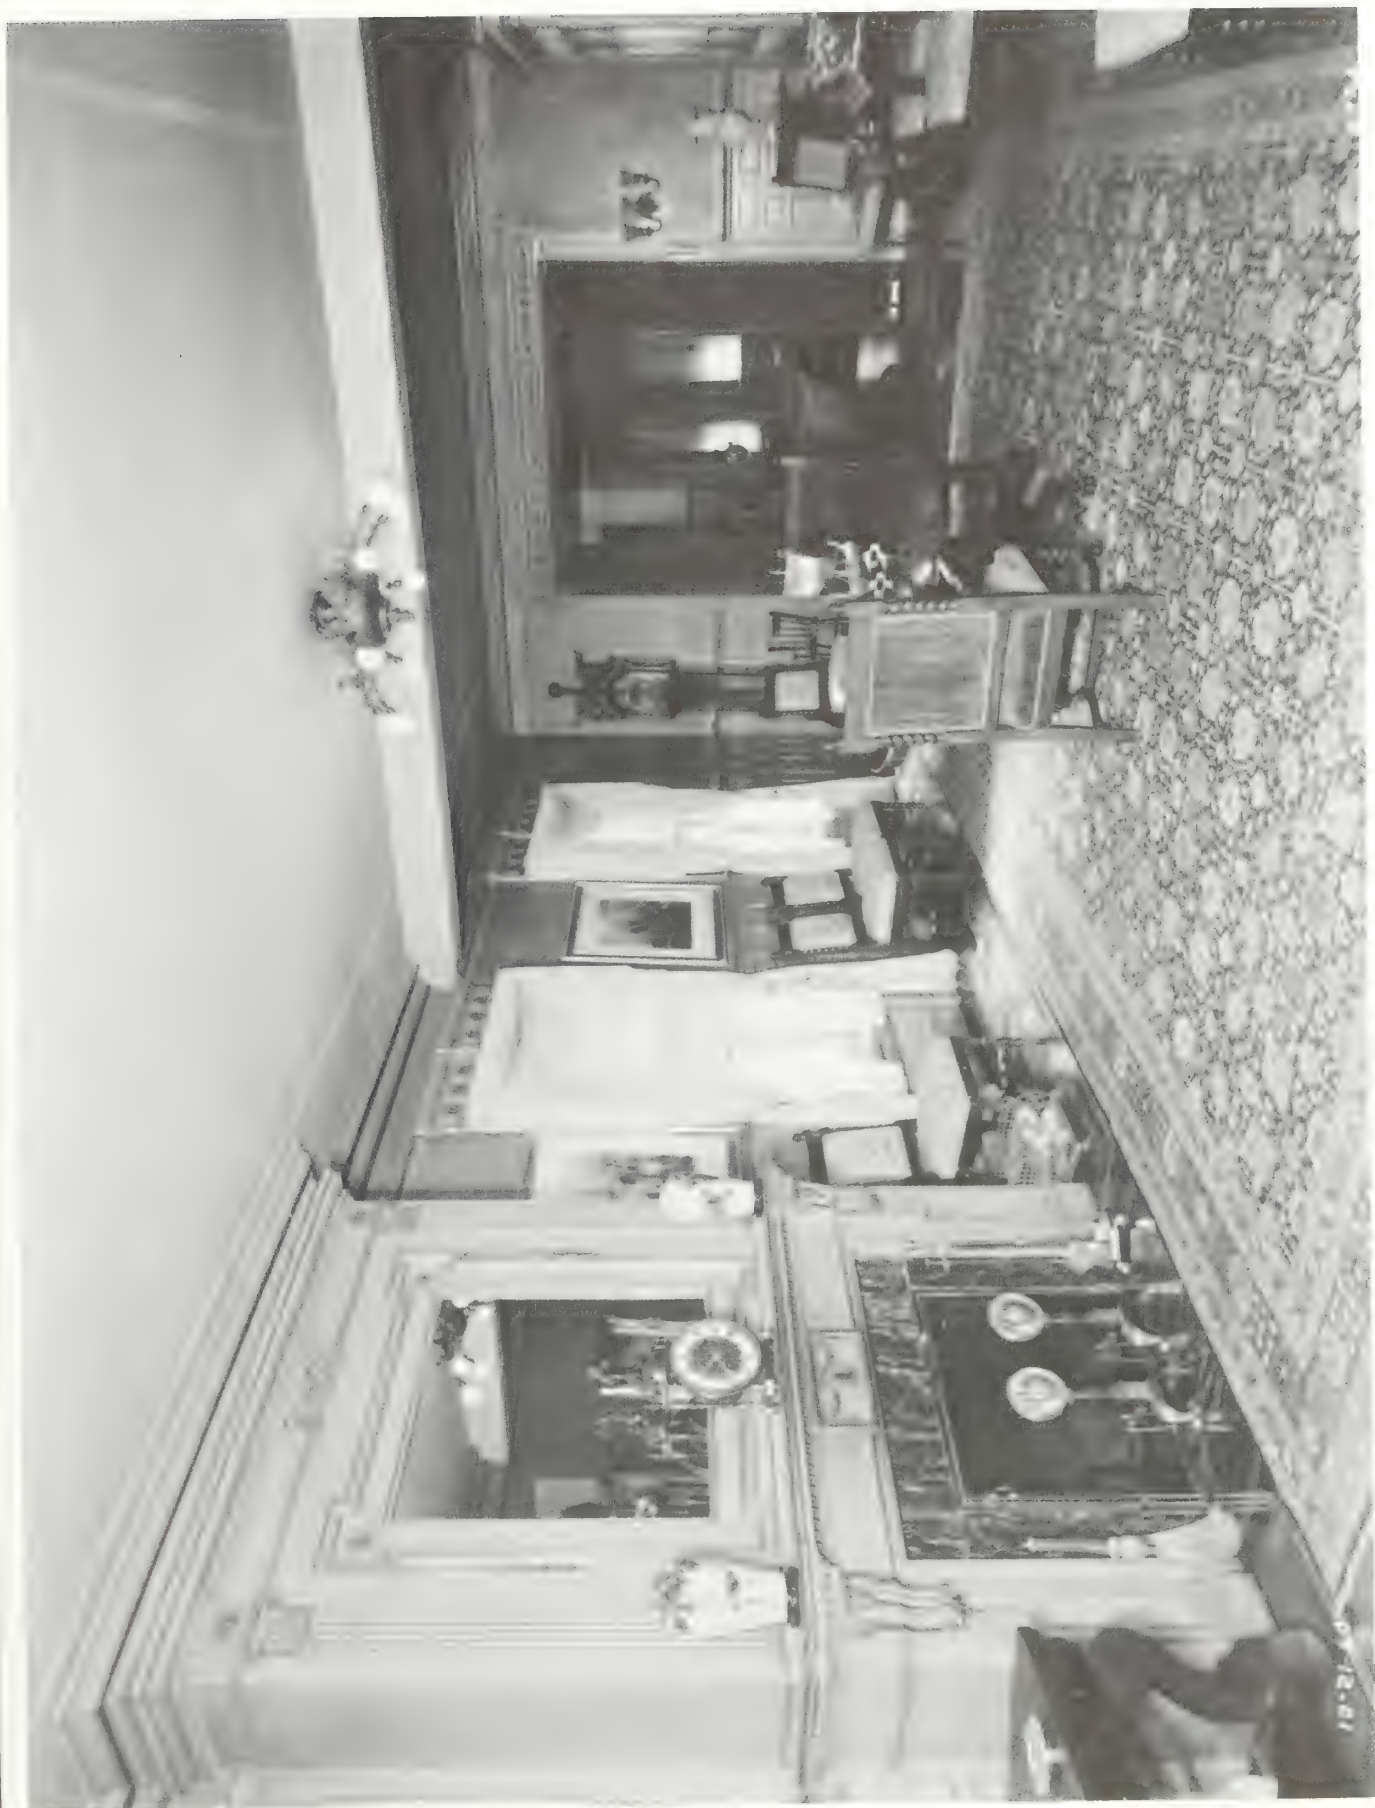
Figure 107. Dining Room (Room 115), looking east, 1947.

The earliest photograph to show the telephone is dated 1947 (fig. 107). The telephone is at the north wall, stored on a small corner shelf on the left (west) side of the built-in sideboard. The telephone cord appears to have been installed in the floor. Telephone instruments were not recorded by the residence or furnishings appraisals, most likely because they were not owned by the Edisons.
